McIntyre Street

32nd Avenue to 64th Avenue Corridor Study

Jefferson County
Department of Highways and Transportation
100 Jefferson Parkway, Suite 3500
Golden, Colorado 80419-3500

April 1999

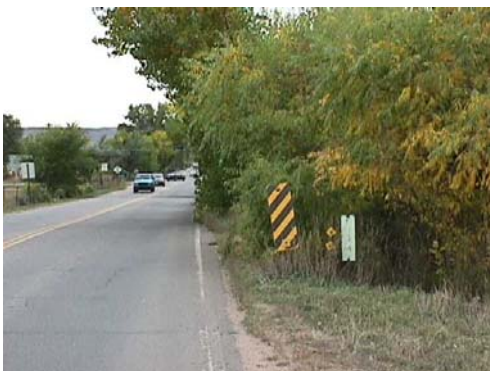
Vegetation protruding into travel lanes

There are also signs in the right of way that are difficult to see due to the vegetation overgrowth in the shoulders. The vegetation should be trimmed back or removed so the signage can be read at the proper distances for adequate warning.

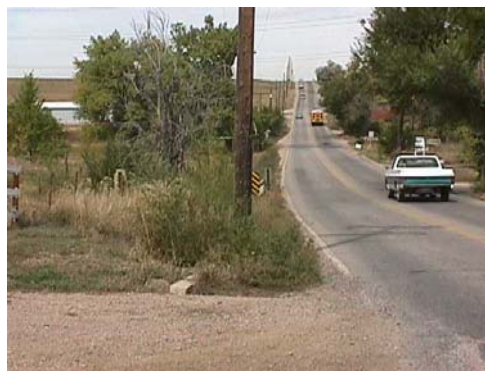
For adequate safety, it is desirable to have a shoulder area for recovery if the motorist unintentionally veer from the travel lanes. Six of the 25 accidents that were non-intersection related may have been avoided if there was an adequate clear zone beside the roadway. According to the AASHTO Roadside Design Guide, shoulder width for a facility with a speed limit at or below 40 mph should be between 10 feet and 15 feet. The shoulders north of 50th Avenue are very narrow to non-existent. There are numerous trees, fences, mail boxes, telephone poles, and other obstructions in the shoulder area that should be moved, removed or signed with object markers.

Inadequate shoulder clear zone

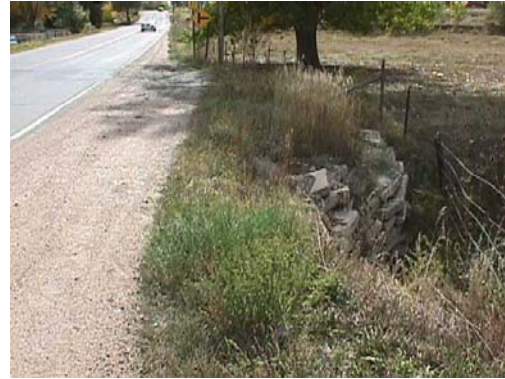
Van Bibber Creek Bridge

New bridge and approach rail needs to be placed at the Van Bibber Creek Bridge. Currently, guard rail is not installed nor are there warnings for this ditch area.

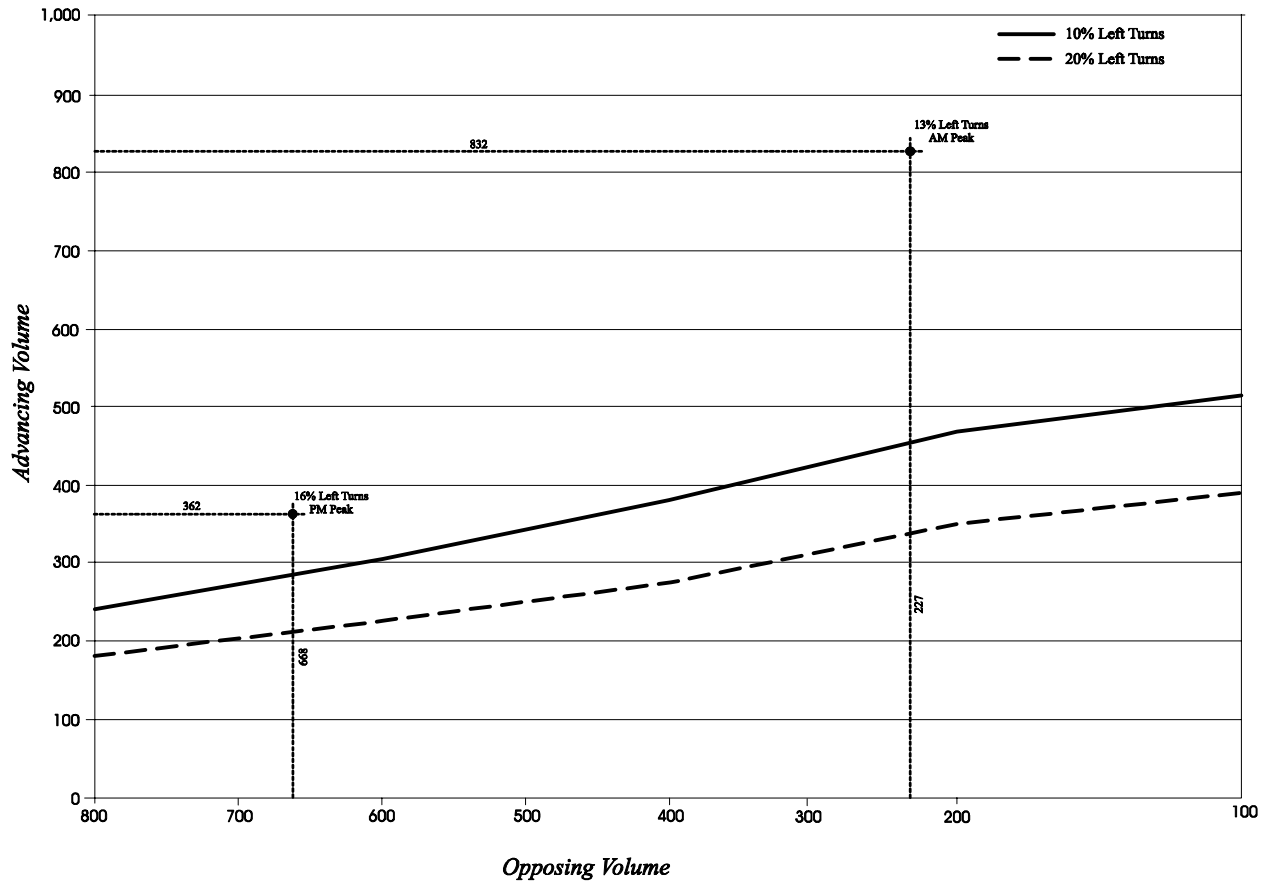
Figure 5.3
52nd Avenue Left-Turn Lane Analysis

While Jefferson County staff was collecting turning movement data at McIntyre Street and 52nd Avenue T-intersection, staff observed that southbound through traffic would use the Diamond Taurus Feed Company parking lot as a through lane when left-turning traffic was waiting for an appropriate gap in traffic.

The existing intersection at 50th Avenue currently has a left-turn lane and left-turn lanes are needed, as documented earlier, at 52nd Avenue, 54th Avenue, and 56th Place. A continuous center turn lane between 50th Avenue and 56th Place should be constructed along this segment of
