**Preliminary  
Pavement Distress Evaluation  
Proposed West Chatfield Avenue Rehabilitation  
South Kendall Boulevard to Ken Cary Road  
Jefferson County, Colorado**

**Job No. 03-0078**

**February 17, 2004**

**Preliminary  
Pavement Distress Evaluation  
West Chatfield Avenue Rehabilitation  
Jefferson County, Colorado**

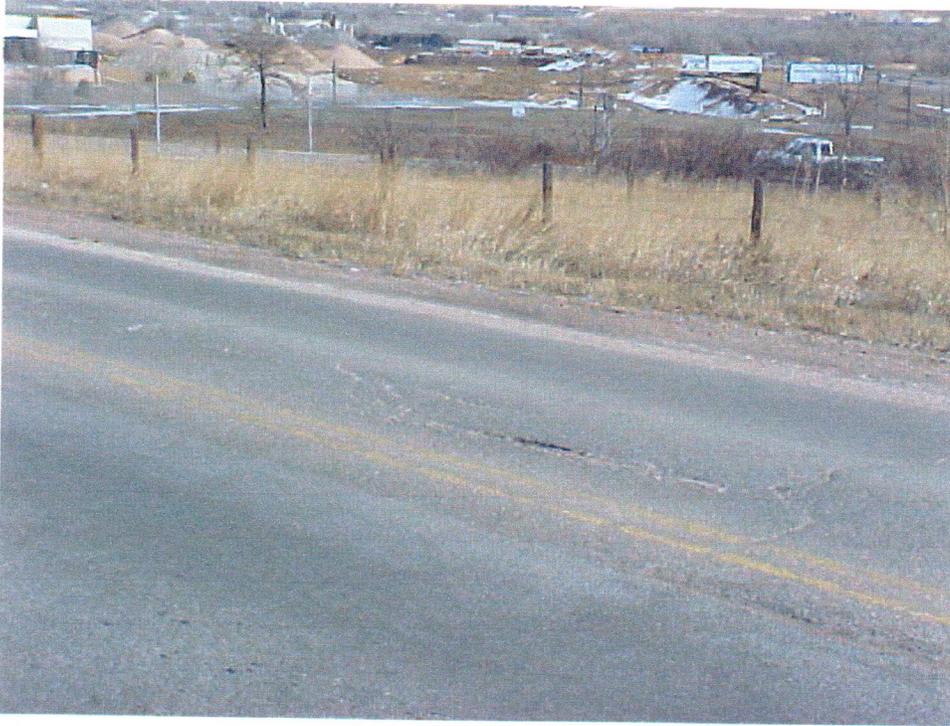
- Station 387+00 to 268+00. This section of the alignment exhibits significant medium severity to severe transverse and longitudinal cracking with associated medium alligator cracking. Severe edge cracking was also observed in localized areas. See relative photographs 1 through 7 in Appendix A.

**Photograph 1 Approximate Station 379+00: View Northeast. Medium to severe transverse and longitudinal cracking with associated alligator cracking.**

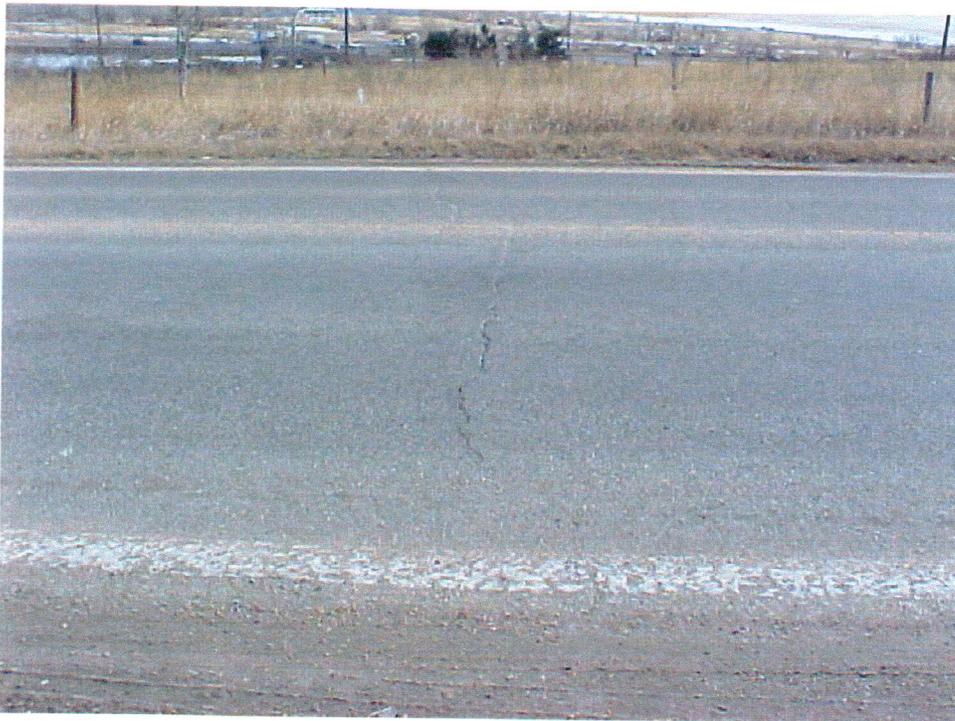
**Photograph 2 Approximate Station 378+50: View east. Medium to severe transverse cracking.**

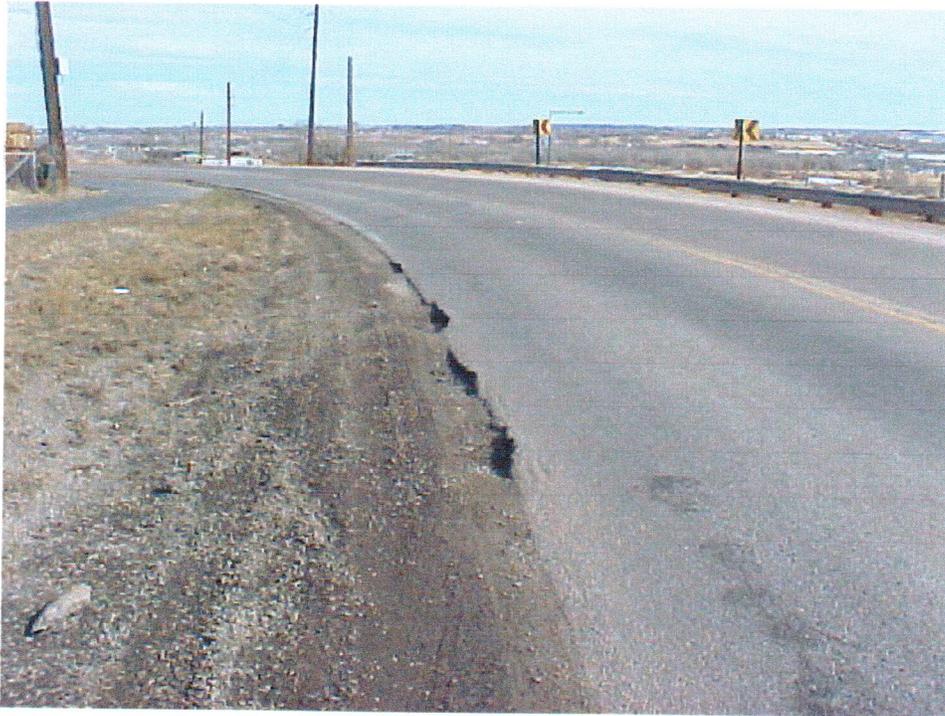
**Photograph 3** Approximate Station 371+00: View northeast. High severity edge cracking.

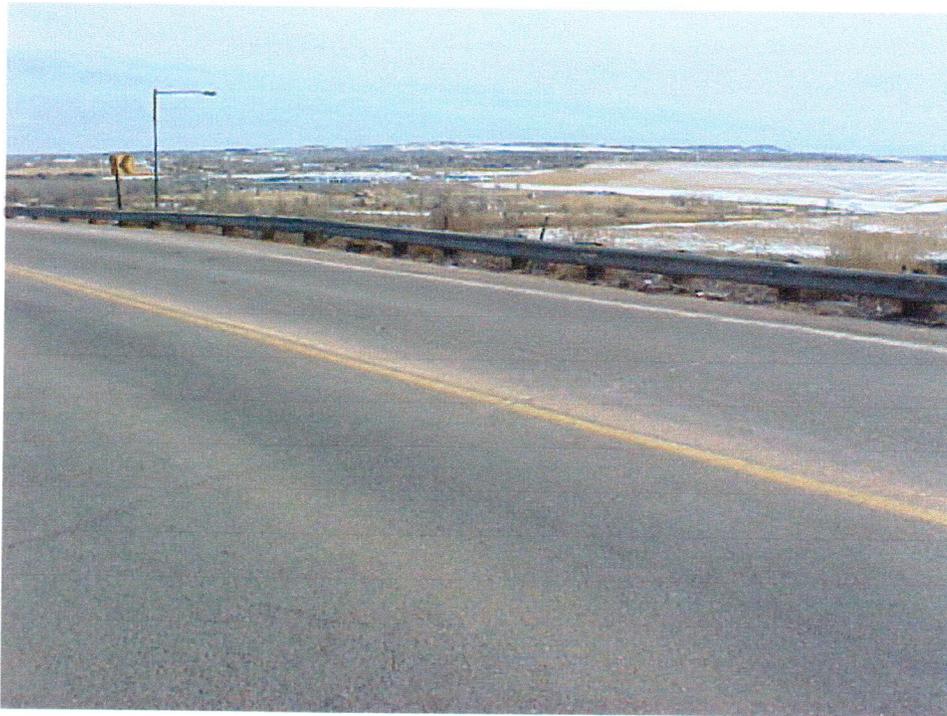
**Photograph 4** Approximate Station 370+75: View southeast. Medium to high severity transverse and longitudinal cracking.

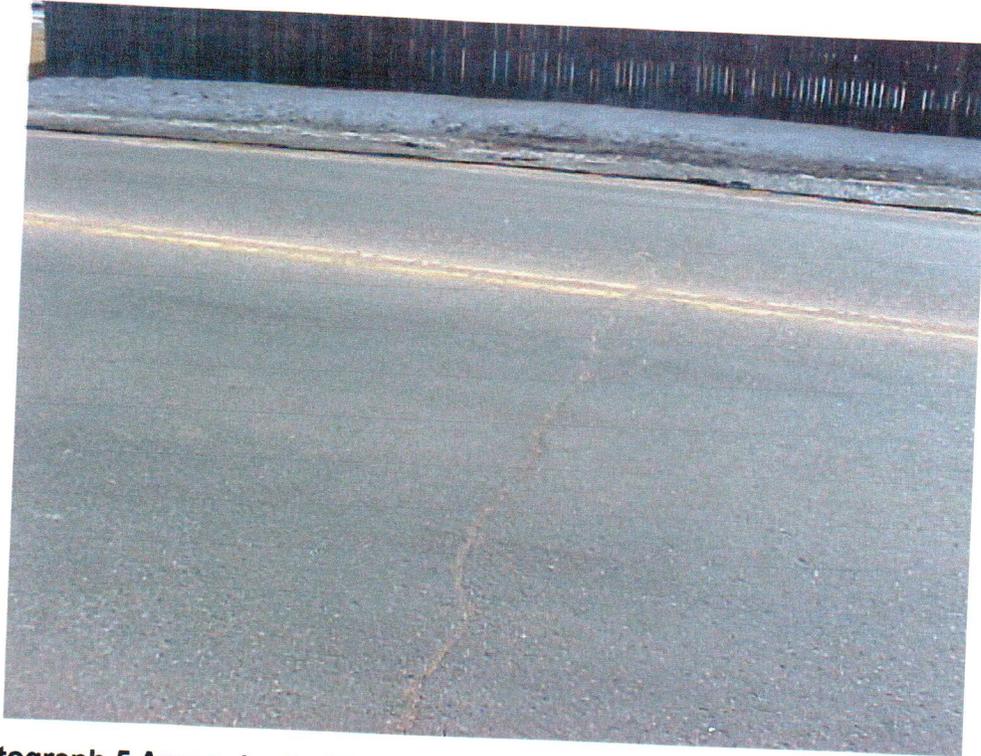
**Photograph 5 Approximate Station 351+00: View south. Medium to high severity transverse and longitudinal cracking.**

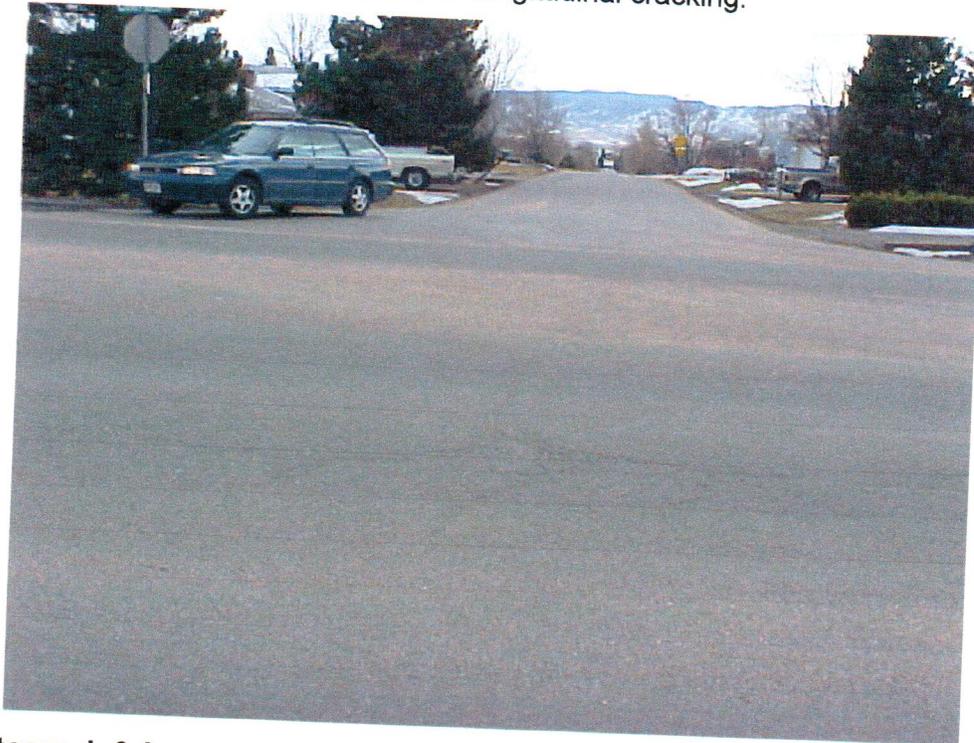
**Photograph 6 Approximate Station 351+00: View south. Medium to high severity transverse and longitudinal cracking with associated alligator cracking.**

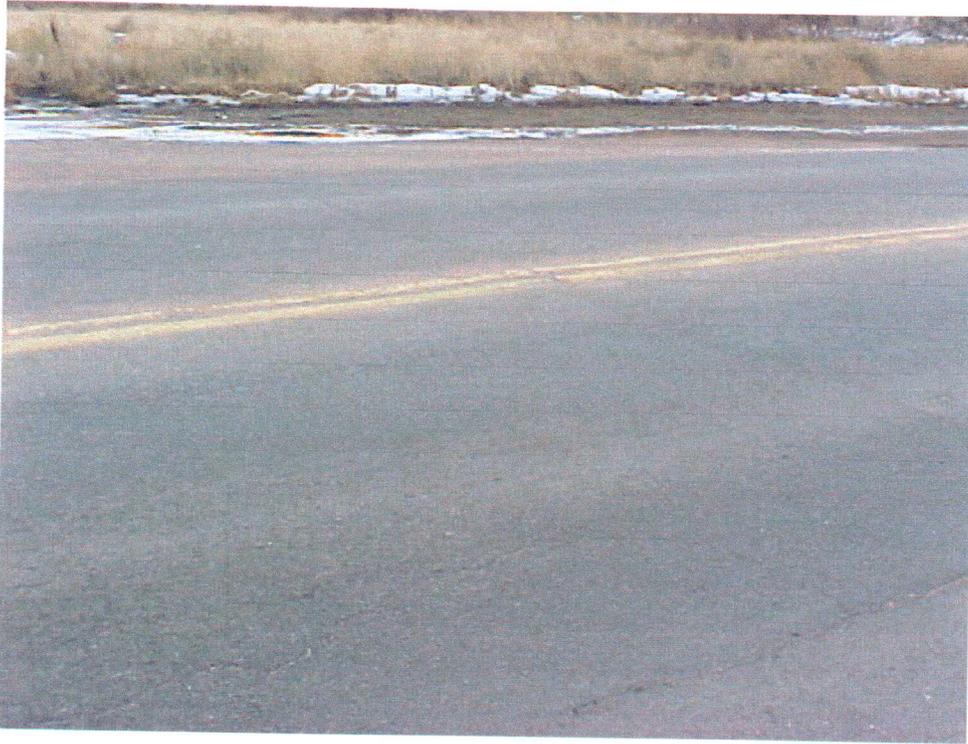
**Photograph 7** Approximate Station 279+00: View southwest. Medium to high severity transverse and longitudinal cracking with associated alligator cracking.

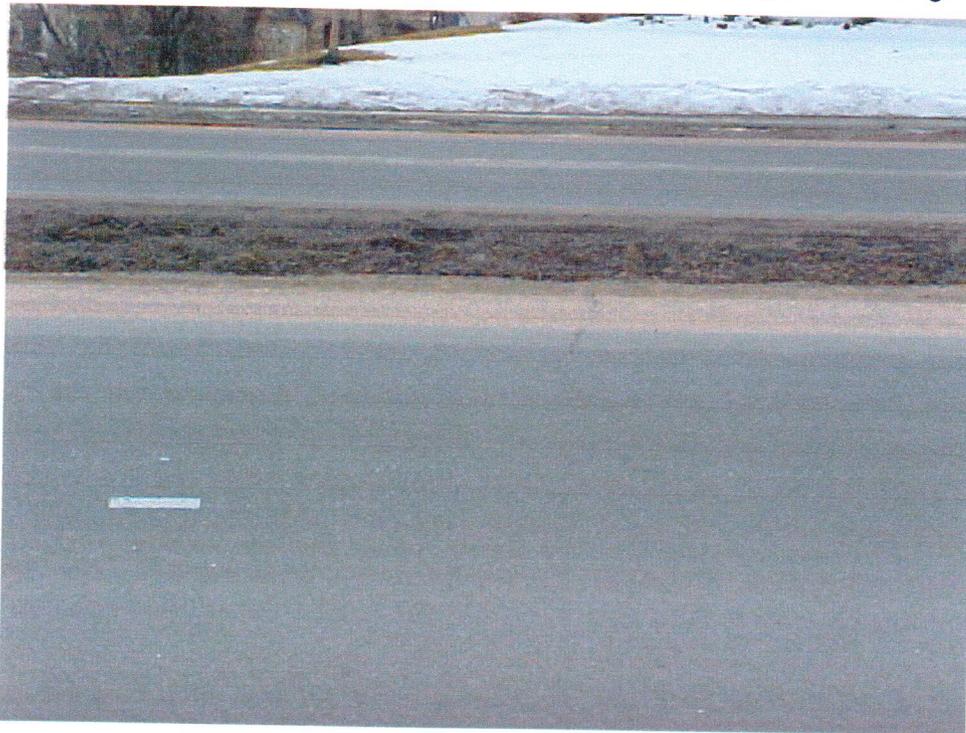
- Station 268+00 to 245+00 This section of the alignment appears to have been overlaid recently and exhibits localized low severity transverse cracking. See relative photograph 8 in Appendix A.

**Photograph 8** Approximate Station 264+00: View south. Isolated low severity transverse crack.

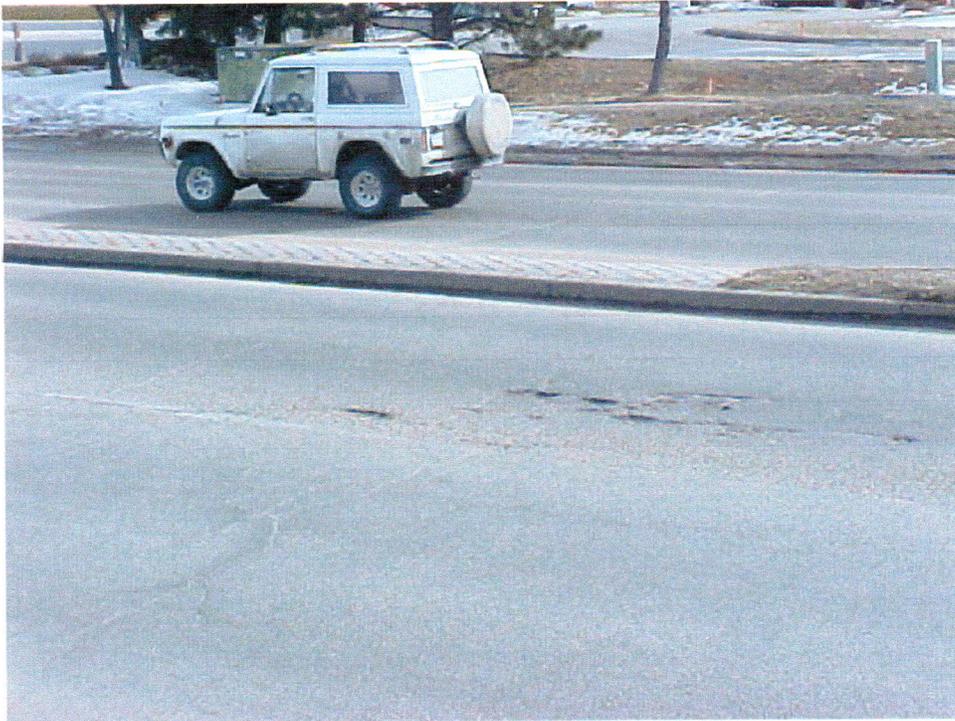
- Station 245+00 to 152+00 This section of the alignment exhibits medium to severe transverse and longitudinal cracking with associated medium severity alligator cracking. Severe edge cracking and medium severity potholes were also observed in localized areas. See relative photographs 9 through 13 in Appendix A.

**Photograph 9** Approximate Station 235+00: View southeast. Medium severity pot holes with associated medium to high severity transverse and longitudinal cracking.

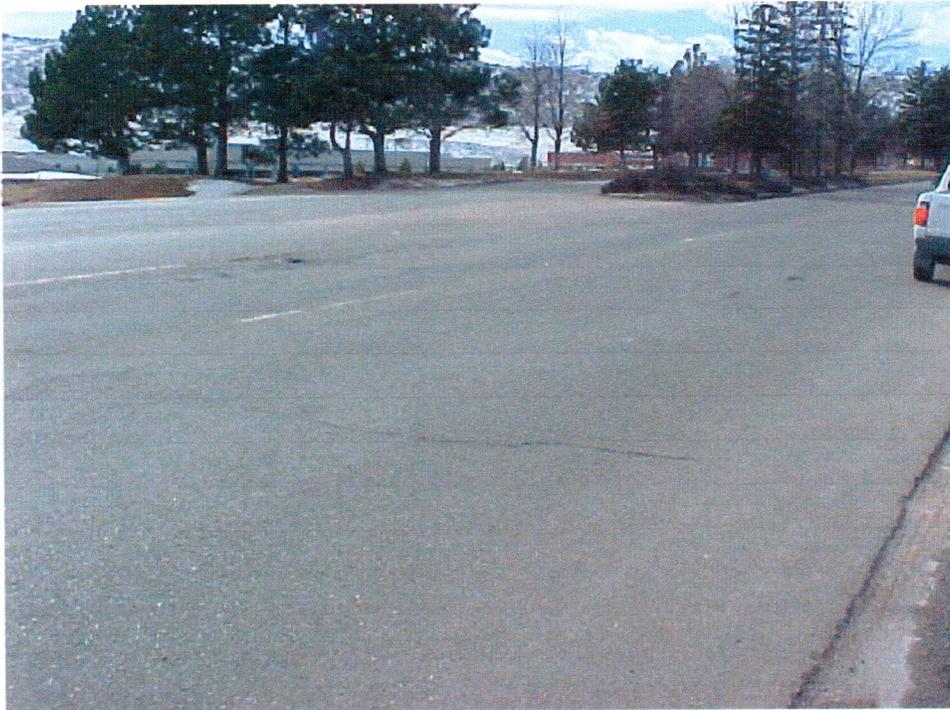
**Photograph 10** Approximate Station 218+00: View southwest. Medium severity pot holes with associated medium to high severity transverse and longitudinal cracking.

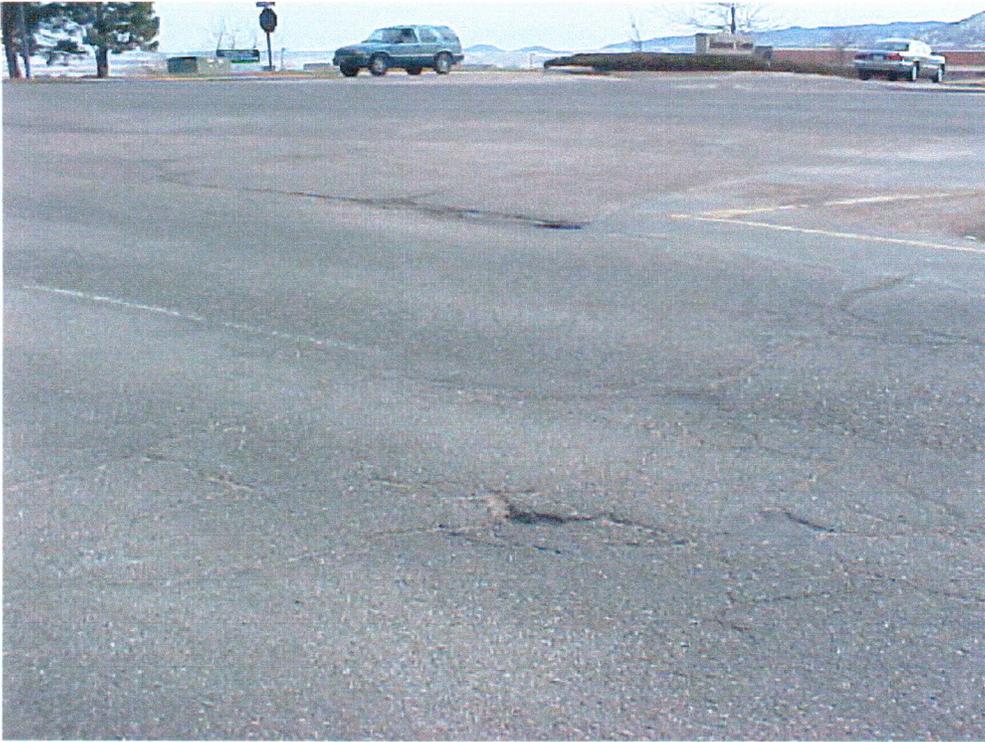
**Photograph 11 Approximate Station 198+50:** View south. Medium severity potholes with associated medium to high severity transverse, longitudinal and alligator cracking.

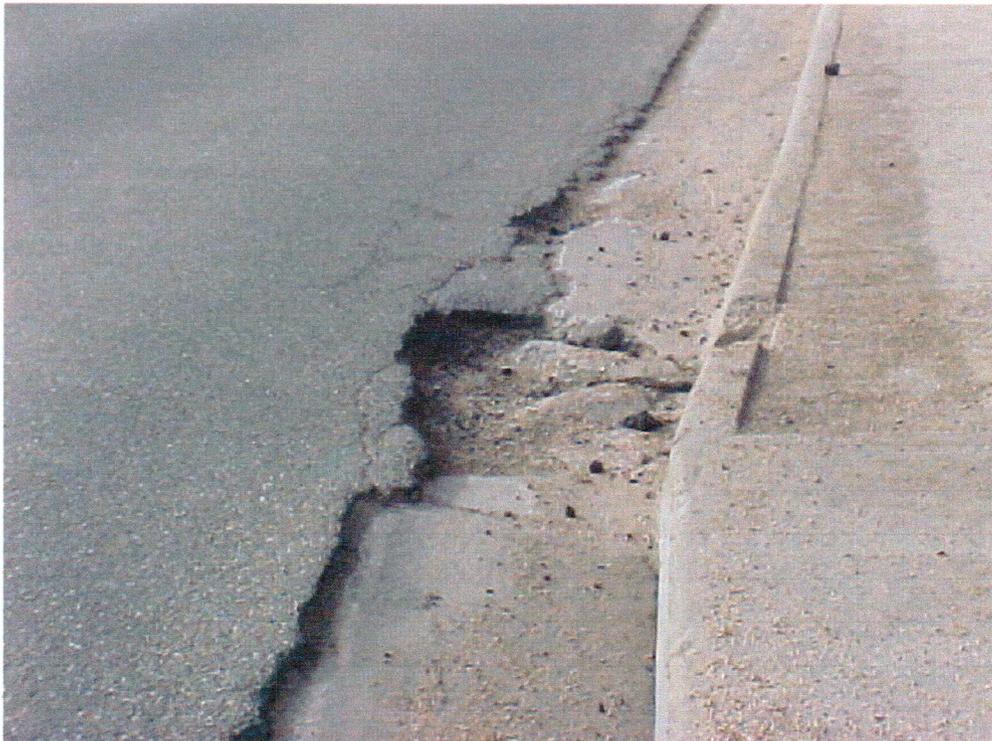
**Photograph 12 Approximate Station 198+25:** View southwest. High severity edge cracking.

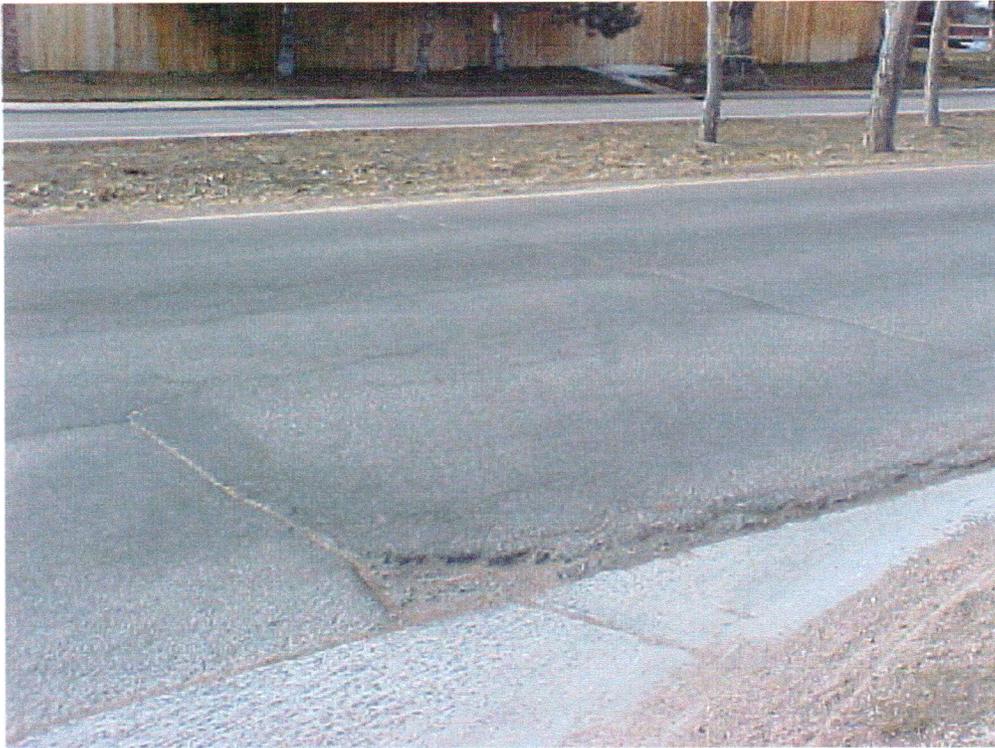
**Photograph 13 Approximate Station 175+00: View west. High severity edge cracking with associated medium to high severity transverse and longitudinal cracking.**
