**South Wadsworth Boulevard/Waterton Road
Intersection Feasibility Study**

Wetland Finding

Jefferson County, Colorado

**Colorado Department of Transportation
and Jefferson County**

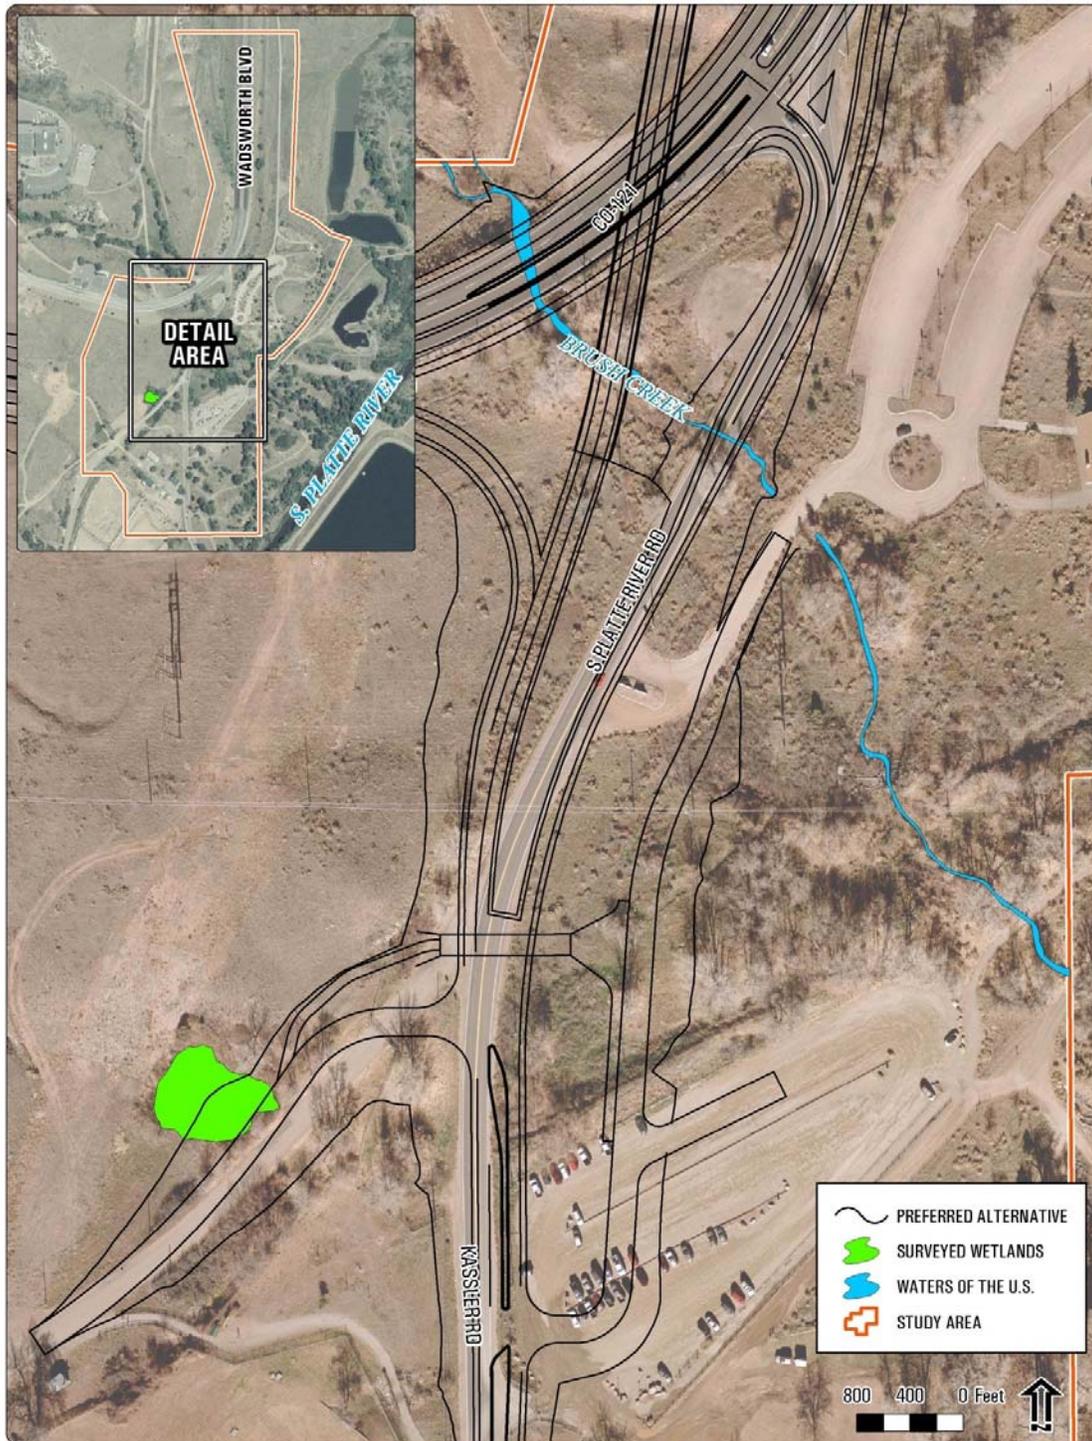
Figure 2: Wetlands and Other Waters of the U.S. in the Study Area

The wetland delineation identified one wetland site totaling 0.16 acre within the Study Area (see **Figure 2**). It is a scrub-shrub wetland dominated by cattail (*Typha angustifolia*), Peachleaf willow (*Salix amygdaloides*), and sandbar willow (*Salix exigua*). Soils in the wetland were characterized by low-chroma and redox features. Standing water was present at the time of survey. Given its topographical location along a hillside, it is assumed that the wetland receives its hydrology from a spring or seep. **Appendix A** provides data sheets and FACWet assessment forms for the wetland and corresponding upland area. Representative photos of the wetland and surrounding upland areas are located in **Appendix B**.

Brush Creek, a water of the U.S. which outfalls into the South Platte River, bisects the study area and is shown on **Figure 2**.

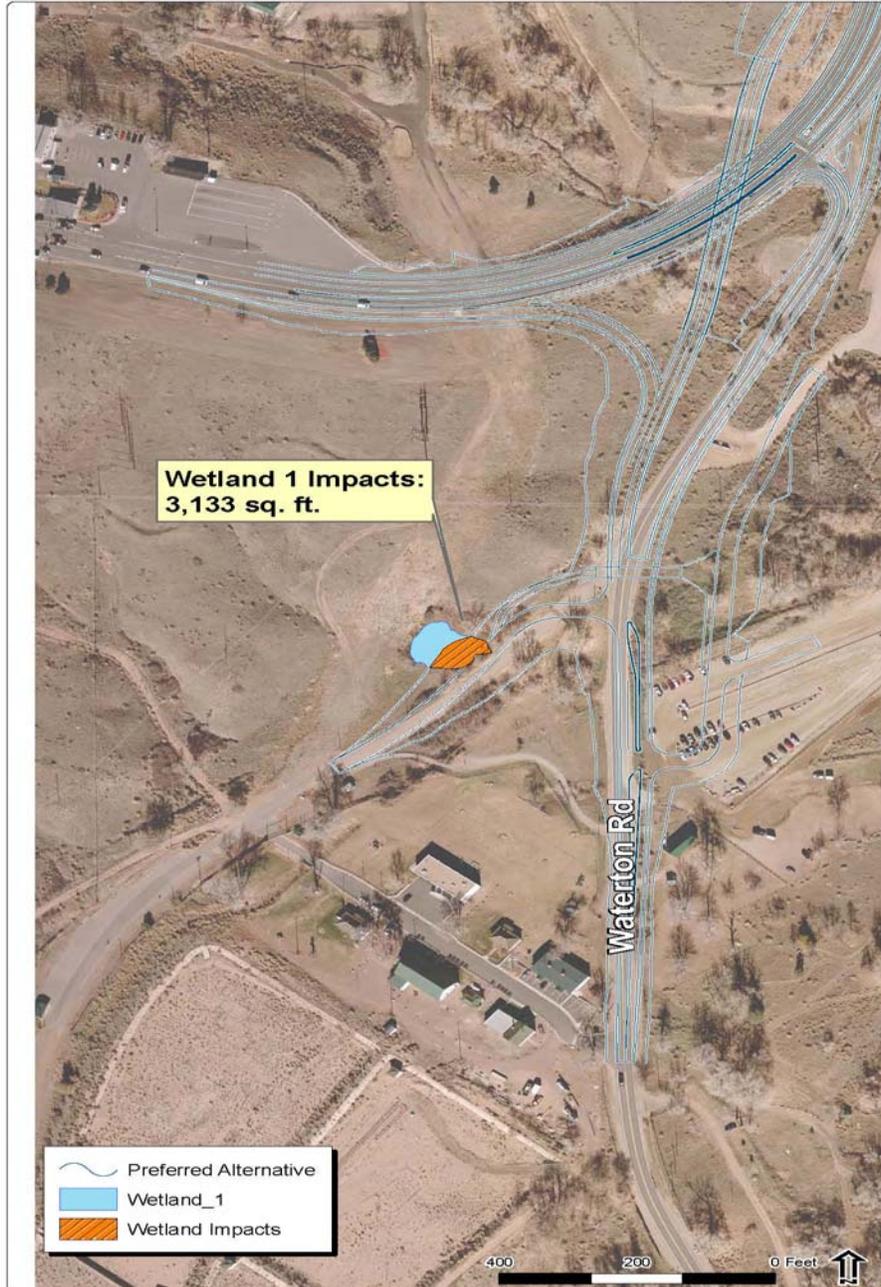
Figure 3: Wetland Impact Area

Based on the Preferred Alternative for the project, approximately 3, 133 sq. ft (0.072 acres) of unavoidable permanent impact and 420 sq. ft (0.0096 acres) of temporary wetland impacts are anticipated (see **Figure 3**). Wetland impact totals will account for approximately 0.509 percent of total wetland acreage within the study area. The impacted wetland is located within the proposed project footprint associated with cut and fill slopes.

This wetland area will be impacted with the horizontal realignment of the existing Denver Water Board Maintenance Access road. Project design has been altered to avoid wetland impact areas where feasible and the final design represents the best effort to avoid and minimize these impacts.

Construction equipment activity is required beyond the permanent fill limits for the proposed improvements; therefore, assuming a 5 foot buffer for construction, temporary impacts to wetlands within the study area would total 420 ft² (0.0096 acres). To minimize the amount of run-off into aquatic features, best management practices (BMPs) will be employed prior to, during, and after construction as discussed below in the **Mitigation** section.

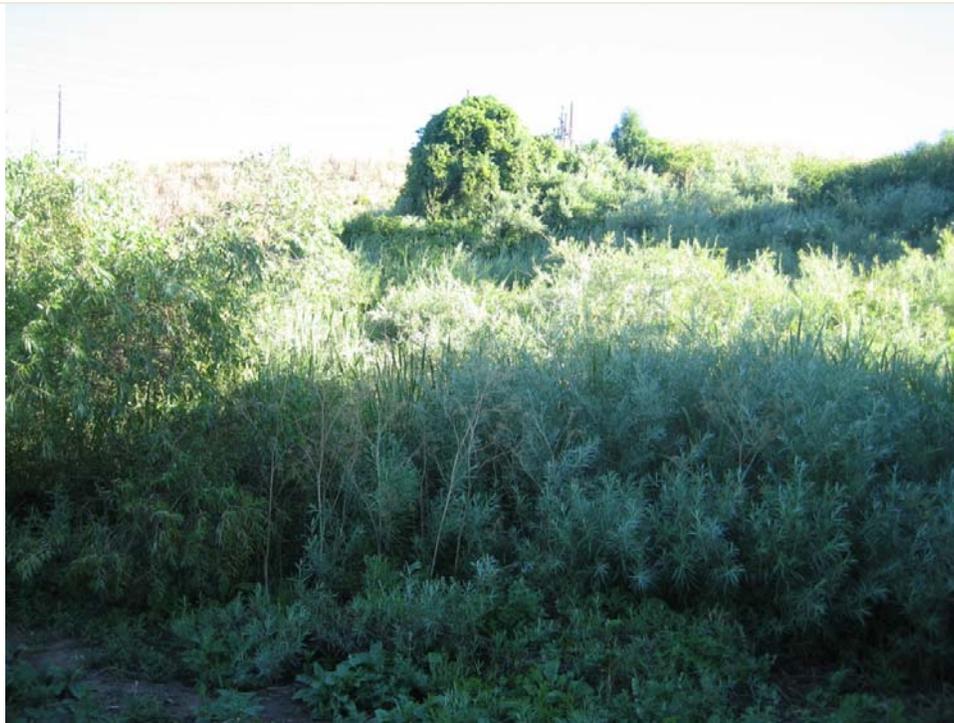
Wetland 1—looking northeast

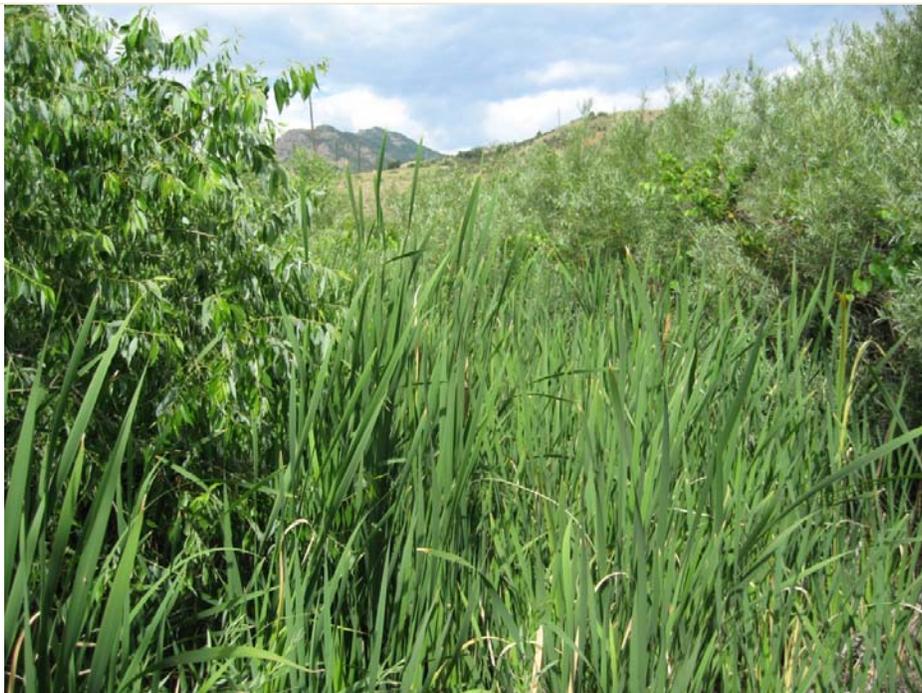
Wetland 1 - looking northwest

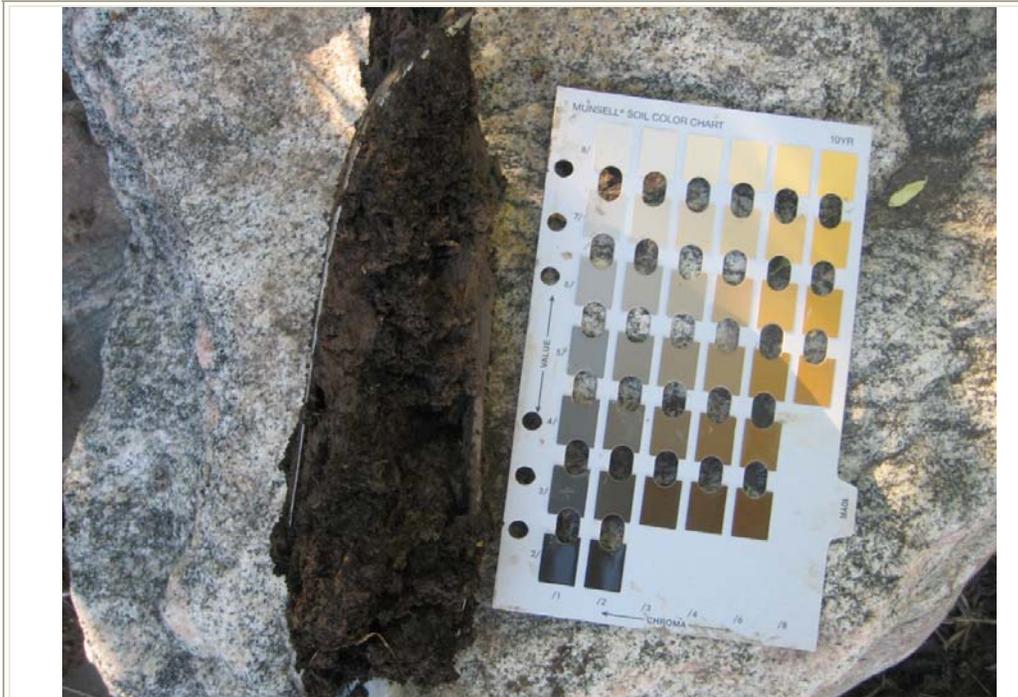
Wetland 1—Soil Profile

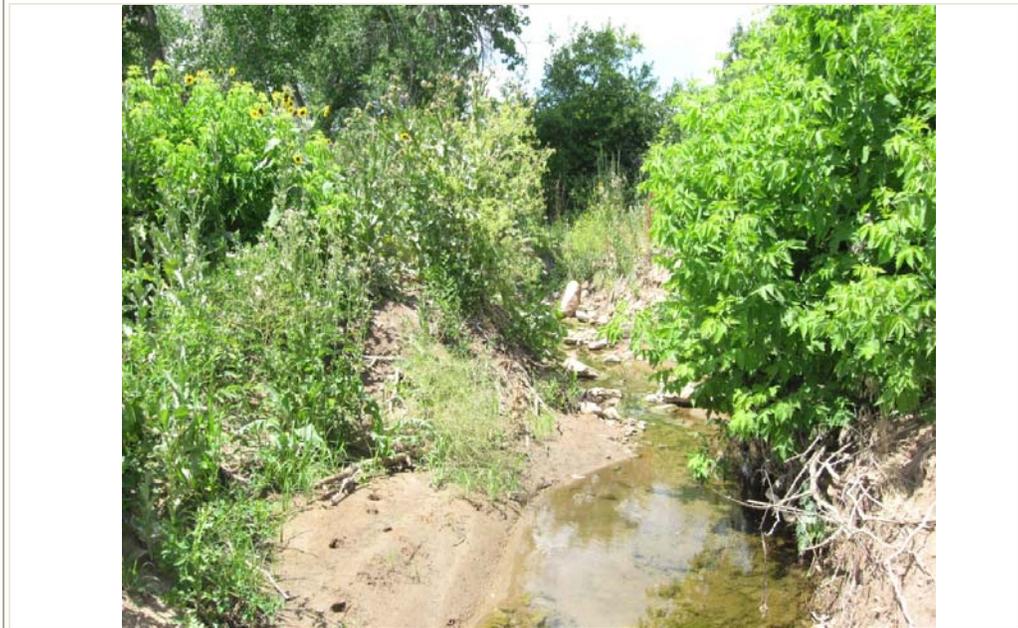
Brush Creek

The Study Area is bisected by Brush Creek, an intermittent stream that flows southeast under South Wadsworth Boulevard to its confluence with the South Platte River. Designated uses for Brush Creek include aquatic life, recreation, and agriculture.
